## Memorandum

**File:** 01-HUM-101-R91.99  
59-93034-N  
0000001016- 6SSCN  
Hiller Rd OC  
Bridge No. 04-0173

**Subject: Evaluation of Fault Rupture Potential, Hiller Road Overcrossing, Bridge No. 04-0173, Post Mile 91.99, Route 101, Humboldt County, California**

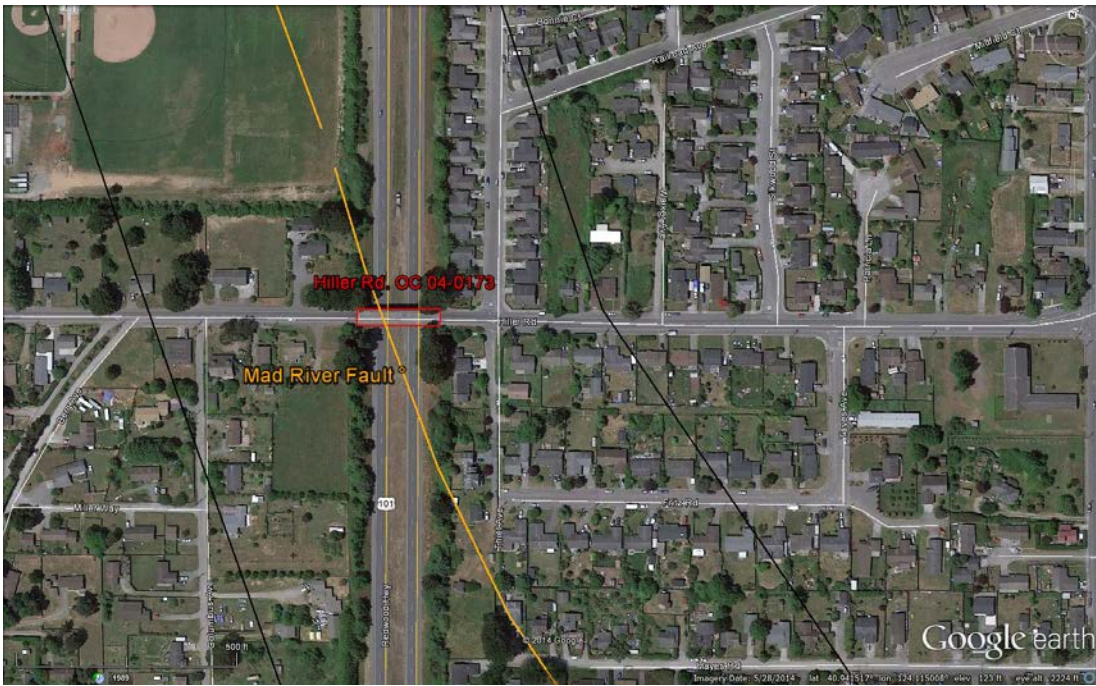
Mckinleyville, Humboldt County (Figure 1). It is situated within the Alquist-Priolo Earthquake Fault Zone for the Mad River Fault as depicted on the Arcata North Quadrangle map (CGS, 1983), Figure 2. Therefore, an evaluation of the fault rupture potential for this bridge is required.

Figure 1. Hiller Road Overcrossing, with fault trace and EFZ boundaries (after USGS/Google Earth Faults, 2014).

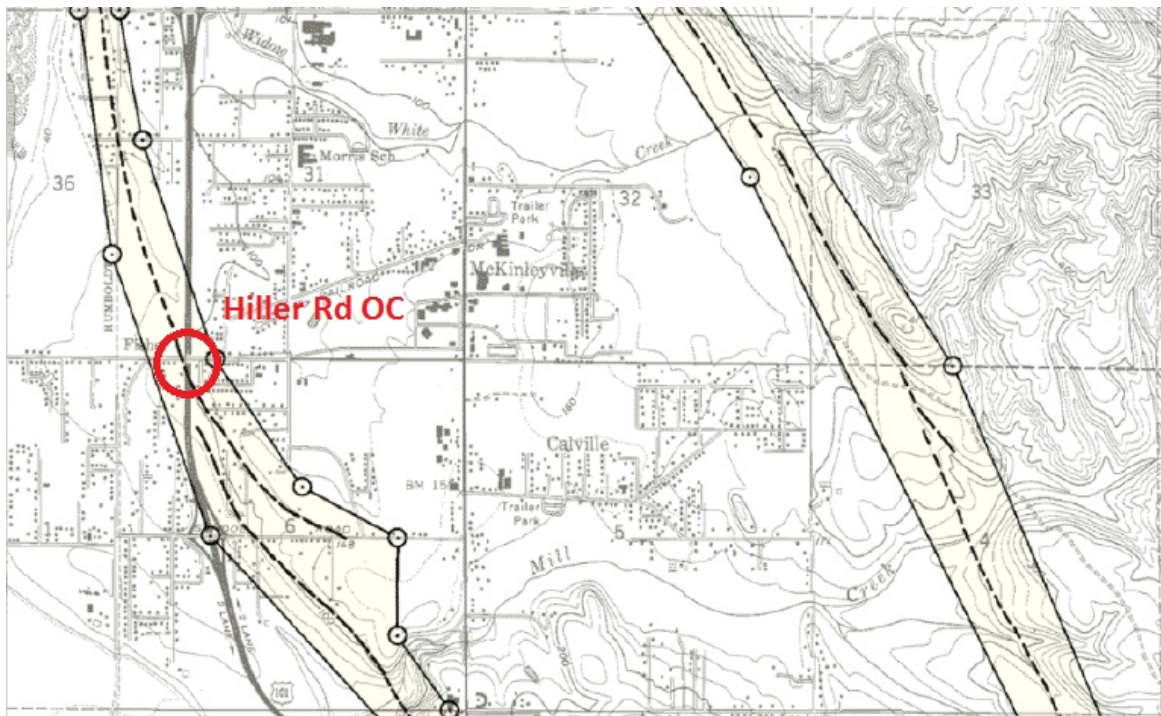
A Fault Evaluation Report (FER 138) was prepared by the Division of Mines and Geology (predecessor of the California Geological Survey) for the Alquist-Priolo Special Studies Zone (now Earthquake Fault Zone) for the Mad River Fault (Smith 1982). The fault zone is depicted on the Arcata North Quadrangle Map (CGS, 1983). In the area of the subject bridge the fault is mapped as several splays, of which passes under the bridge is mapped. The general mapped trend of the Mad River fault in the immediate vicinity of the bridge site has an azimuth of 340°.

Figure 2. After Arcata North Quadrangle Earthquake Fault Zone Map (CGS, 1983).

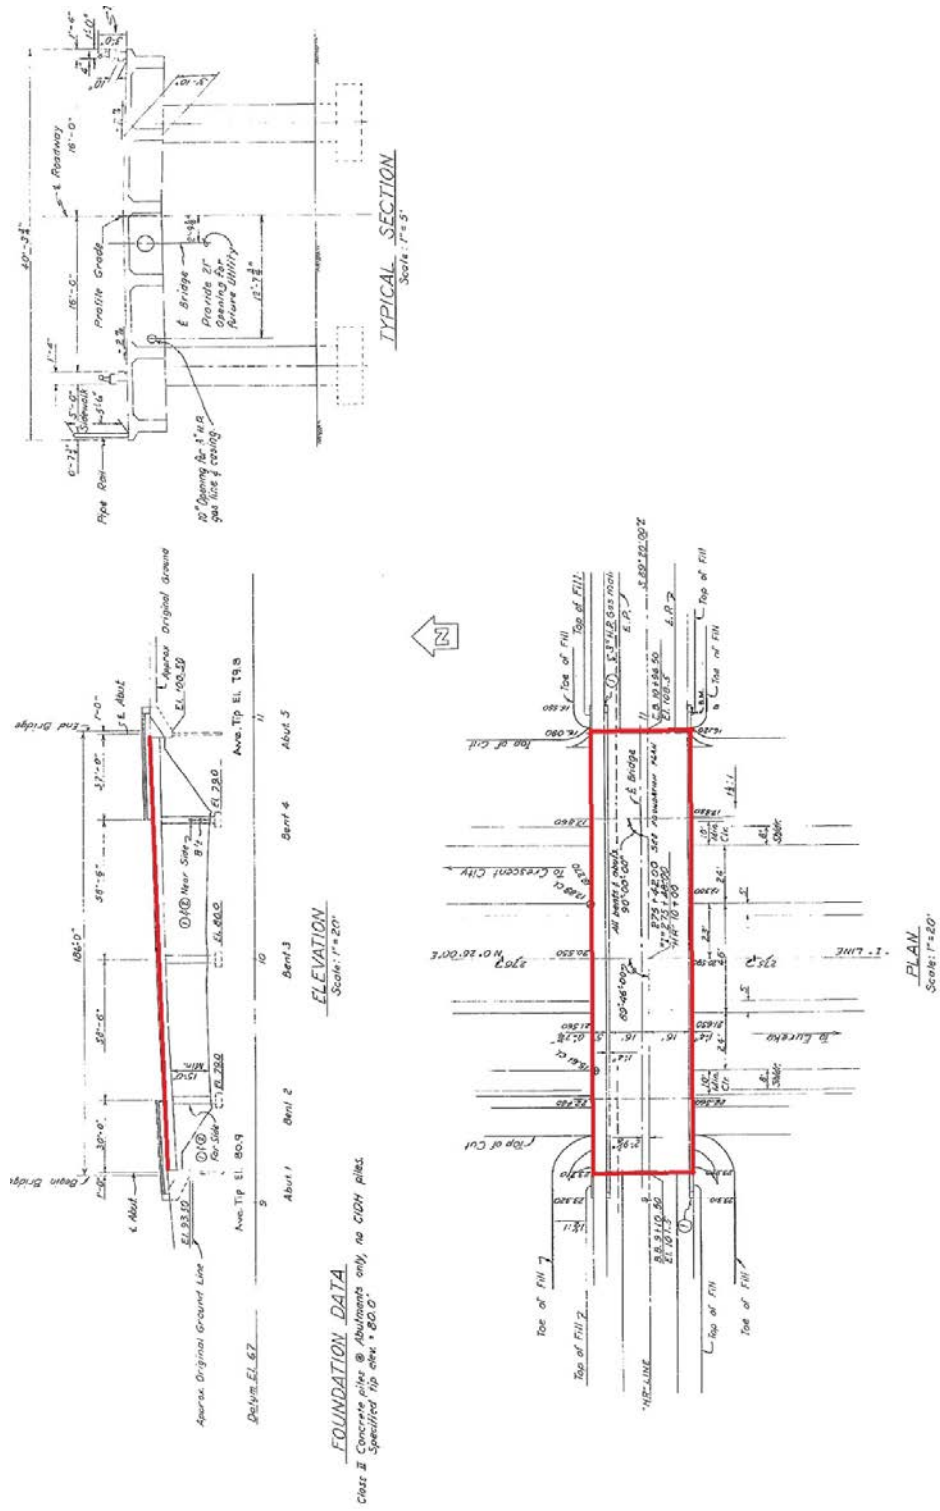
Hiller Road OC was constructed in 1964 as a four span, six continuous T-Beam, reinforced concrete (RC) structure, on diaphragm abutments supported Class II driven piles, and a two - 2 column (RC) bents supported spread foundations. The structure is 186 feet long by 40 feet wide. The overcrossing bridge spans the center median, north and south bound lanes of US 101(Figure 3). The centerline trend of the bridge has an azimuth of 090° and that of the Mad River fault in the vicinity of the bridge site has an azimuth of 340°.

Figure 3: Hiller Road Overcrossing Elevation and General Plan, After As-Built General Plans, 1965.

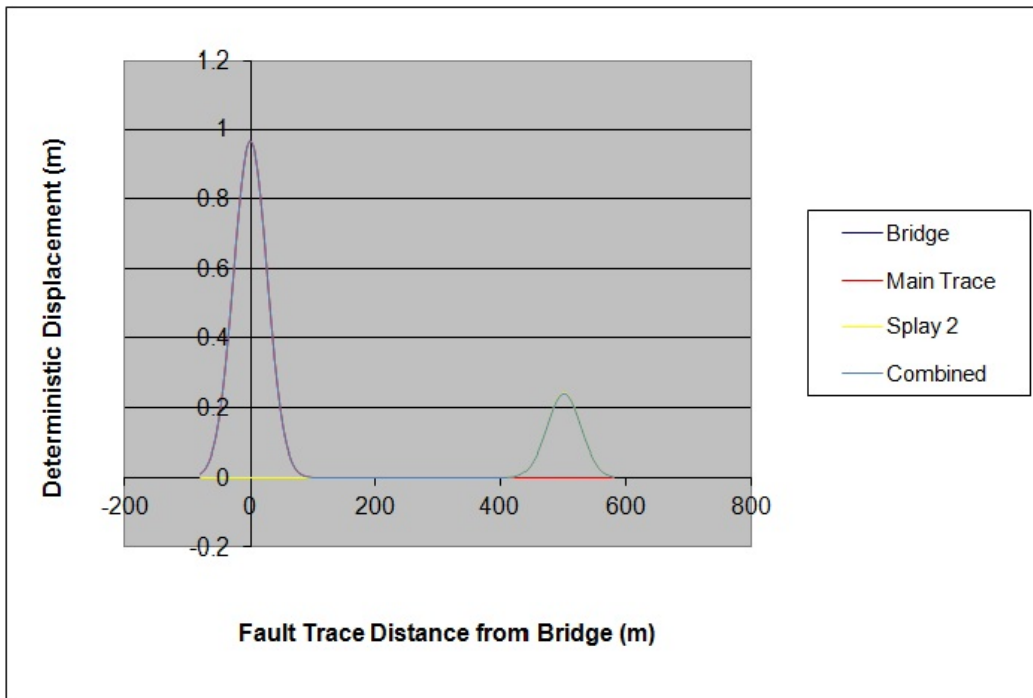
Analysis	Net 80% Displacement	Vertical Displacement	Horizontal Displacement
Deterministic	37in (0.95m)	19in (0.48m)	19in (.82m)
<b>Probabilistic</b>	<b>52 in (1.31m)</b>	<b>26in (0.66m)</b>	<b>45in (1.13m)</b>

**At the bridge site the expected probabilistic displacement would be about 26 inches vertical and 45 inches horizontal.** The resultant graphs of these analyses are respectively shown on Figures 4 and 5.

Figure 4: 37 inches (0.95m) of Deterministic displacement at the bridge

Additional work to accurately locate the fault in the field is recommended if it is determined that the bridge structure cannot accommodate the reported amounts of lateral displacement. Please contact Douglas Cook at (916) 227-4514 if you have any questions.

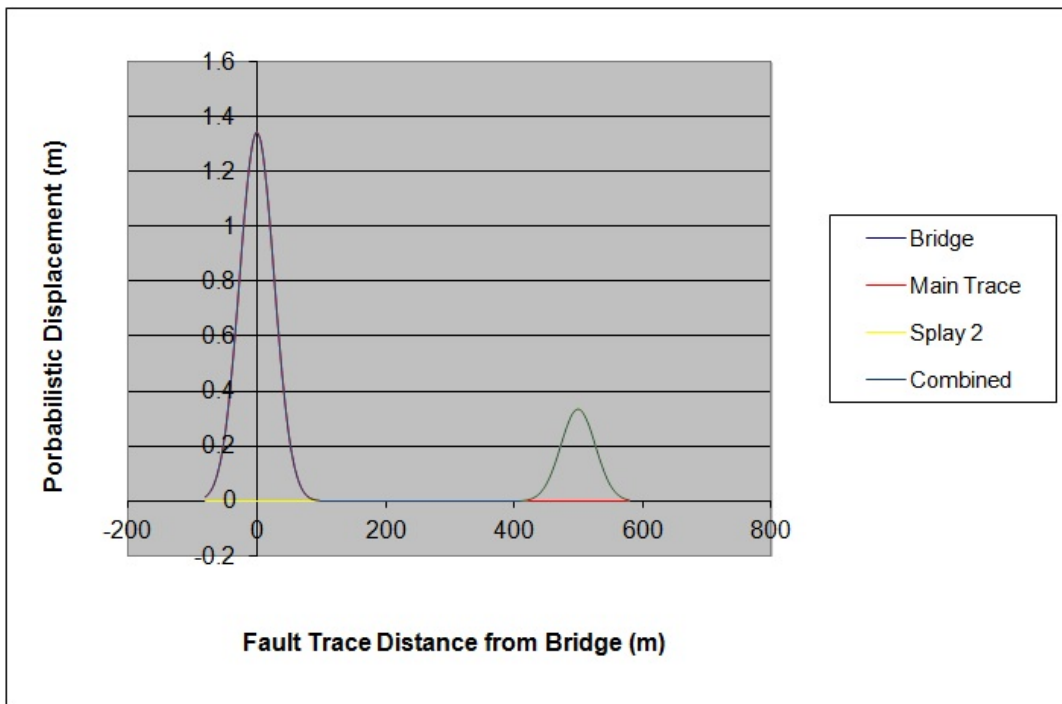
Figure 5: 45 inches (1.31m) of Probabilistic displacement at the bridge
