Memorandum

File: 01-MEN-01, PM 22.73
0000001016 6SSCN
Alder Creek Bridge
Bridge No. 10-0116

Subject: Evaluation of Fault Rupture Potential (revisions in red), Alder Creek Bridge, Br. NO. 10-0116,
Mendocino County, California

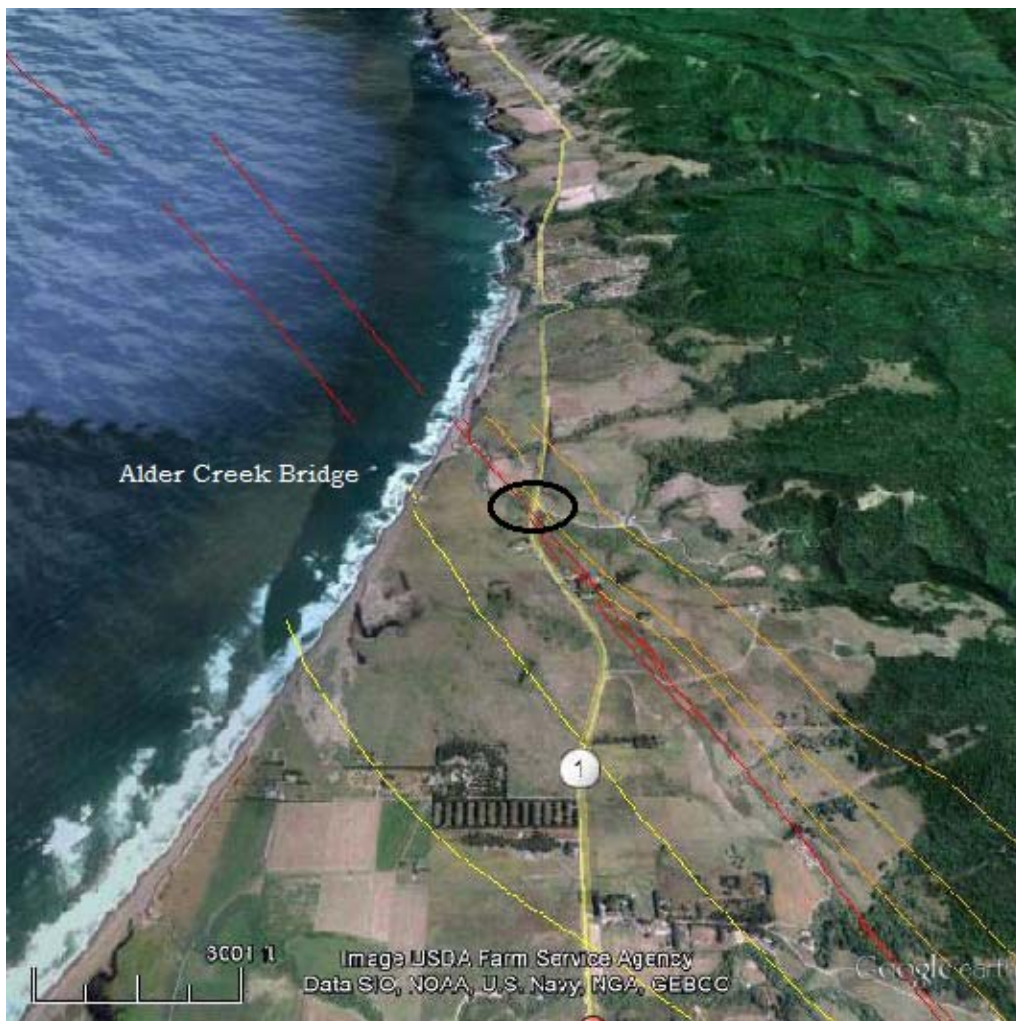
Figure 1. Alder Creek Bridge. Red lines represent historically active traces of the San Andreas Fault, others are older traces. Two red lines near the bridge represent the main trace to the east and a secondary older trace to the west (Baldwin, 1996).

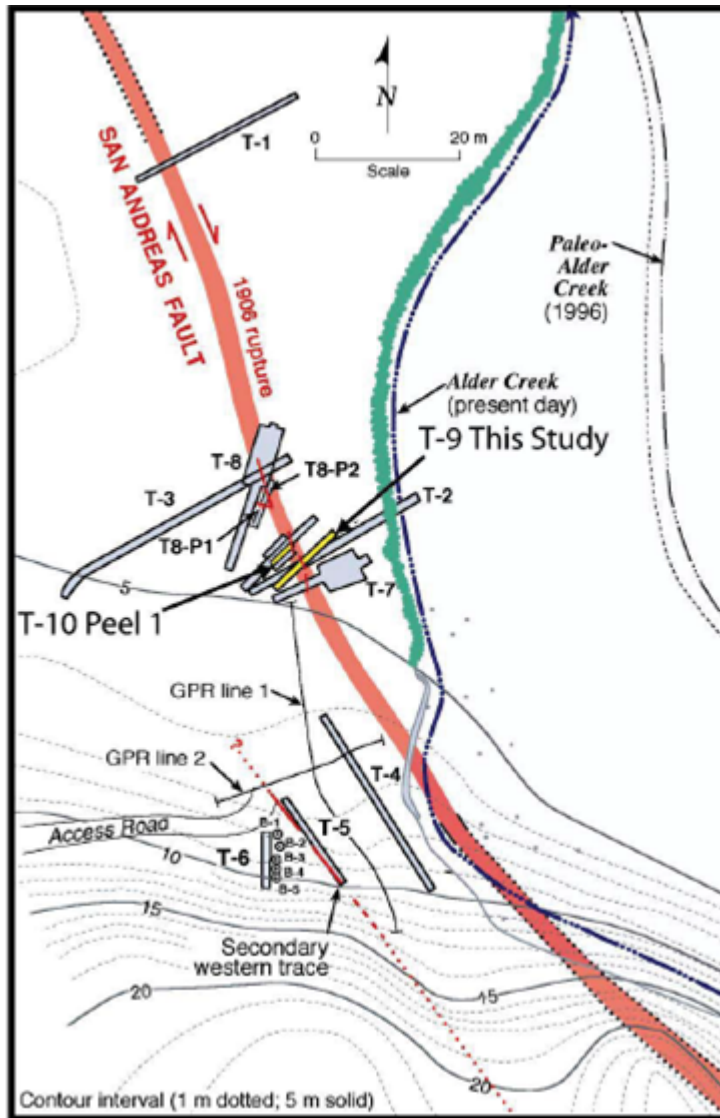
1. Figure 2 shows the location of work done for a master's thesis consisting of mapping, trenching, and (later) ground-penetrating radar (GPR) at a site directly southwest of the bridge (Baldwin, 1996; Baldwin et al, 2000). John Baldwin mapped several traces of the fault, including a main trace identified in trenches. The main trace of the fault was further studied in a GPR survey that confirmed the earlier location. The main trace is 1-3 m wide. If this trace is projected NW 100 feet to Alder Creek Bridge at the range of angles noted in the nearest trench

Figure 2. Excavations and geophysical lines performed southeast of Alder Creek Bridge. Trenches 1-8 and 10 from Baldwin (1996) and Baldwin et al, 2002); Trench 9 and Trench 10 peel of Baldwin's trench from Crawford (2007). Bridge location is approximately 100 feet north of T-1 on trend with the San Andreas Fault.

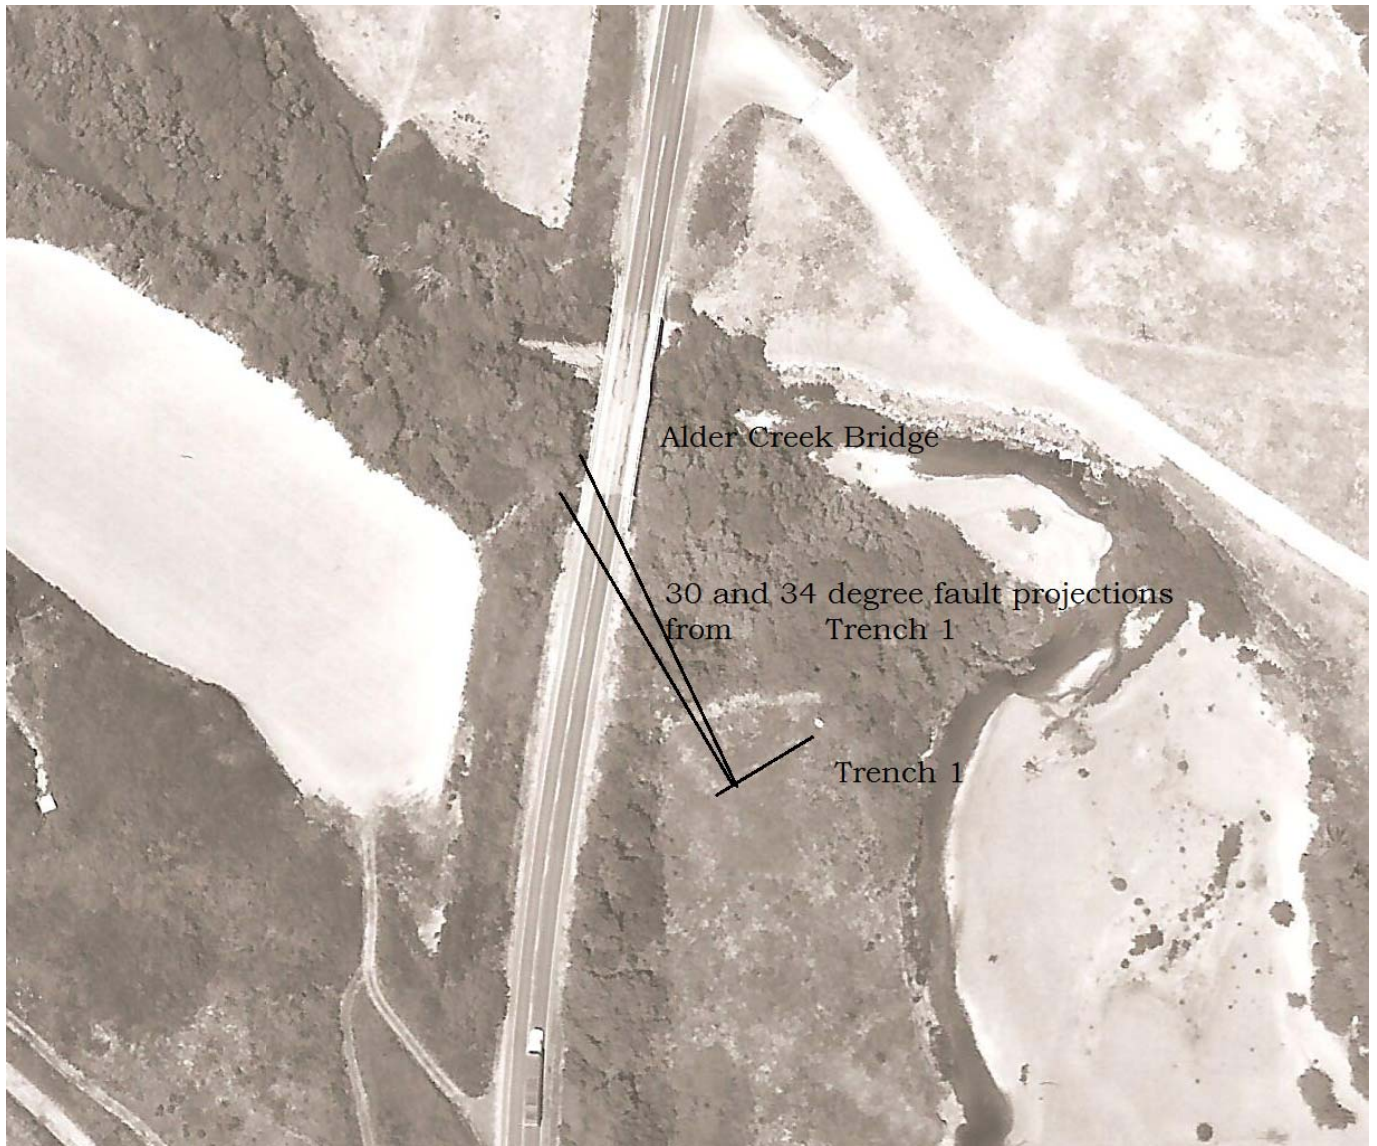
(30-34 degrees northwest), the fault crosses beneath the southern portion of the bridge (Figure 3).

Man-made features such as the bridge and highway obscure fault traces at the bridge. Aerial photos taken in 1956 and 1999 (Figure 3) were reviewed. No photos taken prior to bridge construction were available. The San Andreas Fault in this area consists of several linear strands seen clearly several hundred feet south of the bridge on the air photos. The Alder Creek drainage where the fault trends northwest of the bridge to the ocean contains fluvial deposits too recent to allow for observation of the fault. Lidar imaging (Figure 5) clearly reveals the main trace of the San Andreas Fault southeast of the bridge but not at or northwest of the bridge. The main trace is visible near the location of the bridge destroyed in 1906 near the mouth of Alder Creek.

Figure 3. 1999 air photo showing location of 1996 Trench 1 and projection of the San Andreas Fault from Trench 1 towards the bridge. North is at top of image.

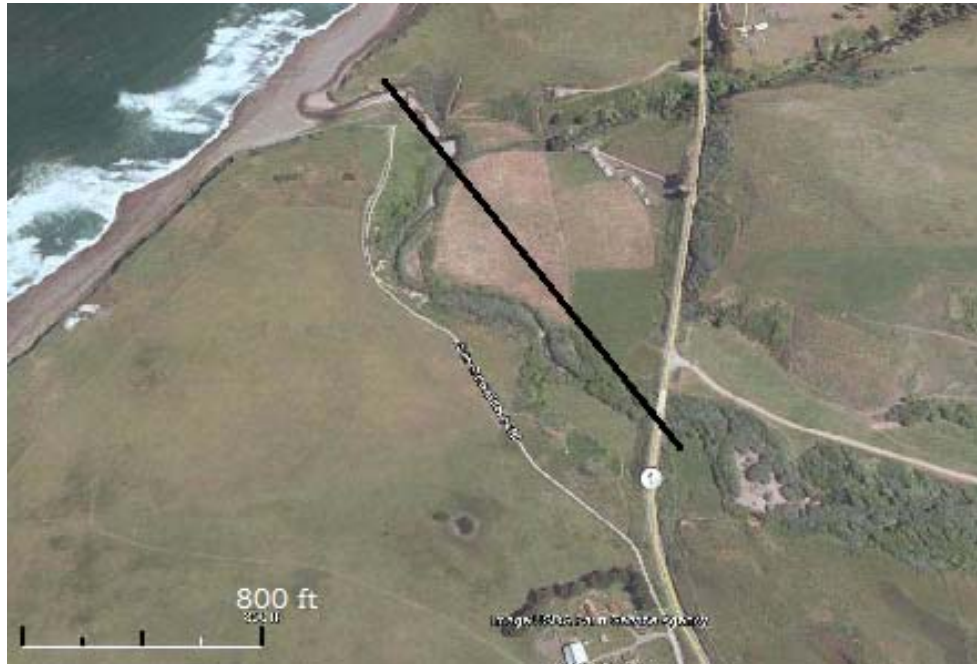
2. If the main trace is extended northwest 1/3 mile towards the next locale where the fault has been identified near the mouth of Alder Creek, the main trace crosses the southern portion of the bridge (Figure 4).
3. A 1995 Preliminary Seismic, Geologic, and Foundation Information Memorandum for the proposed bridge retrofit noted that based on the 1945 General Plan the bridge is underlain by silt, clay, sand, gravel, and sheared shale bedrock (Caltrans memo to E.Wahl, 2/3/1995). Depth to bedrock was assumed to be between 10 and 80 feet. Sheared bedrock is characteristic of faulting, although the observation does not necessarily mean the main trace is under the bridge.

Figure 4. Black line connects known locations of the historically-active San Andreas Fault north and south of Alder Creek Bridge, and trends beneath southern end of Alder Creek Bridge.

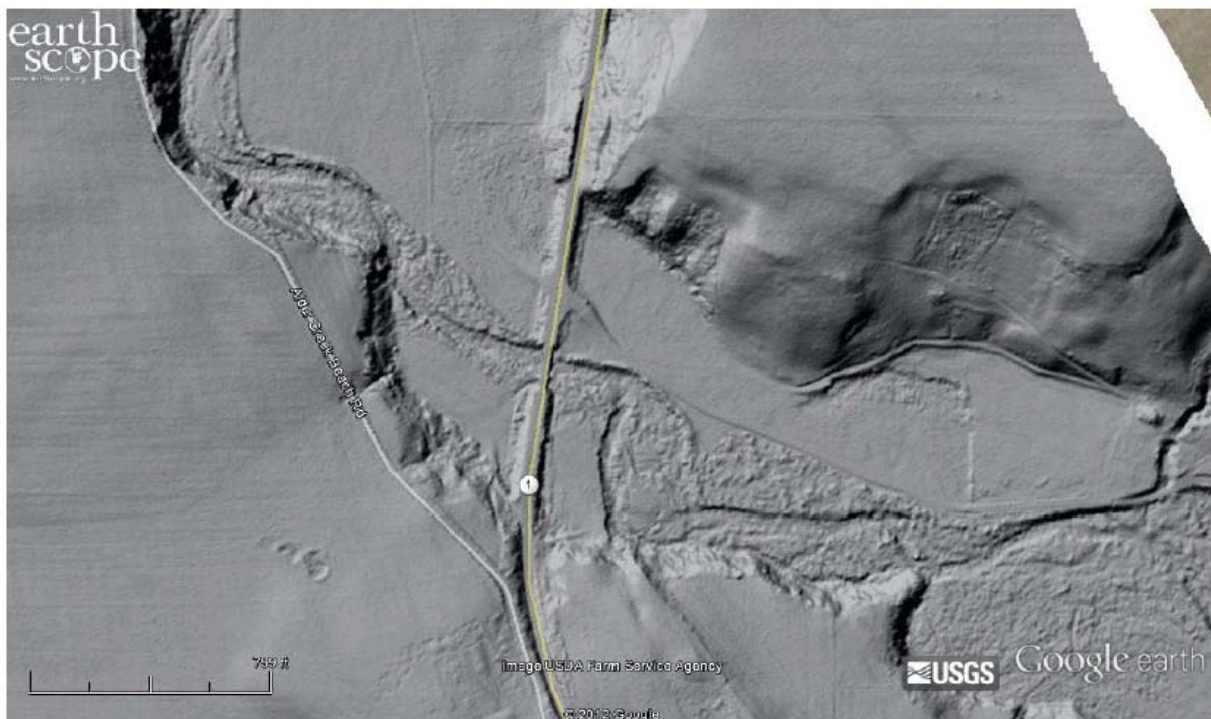
Figure 5. Lidar imagery, showing ridge south of the bridge. Fluvial deposits from the creek obscure the natural ground features in addition to man's activity such as construction of Hwy 1.

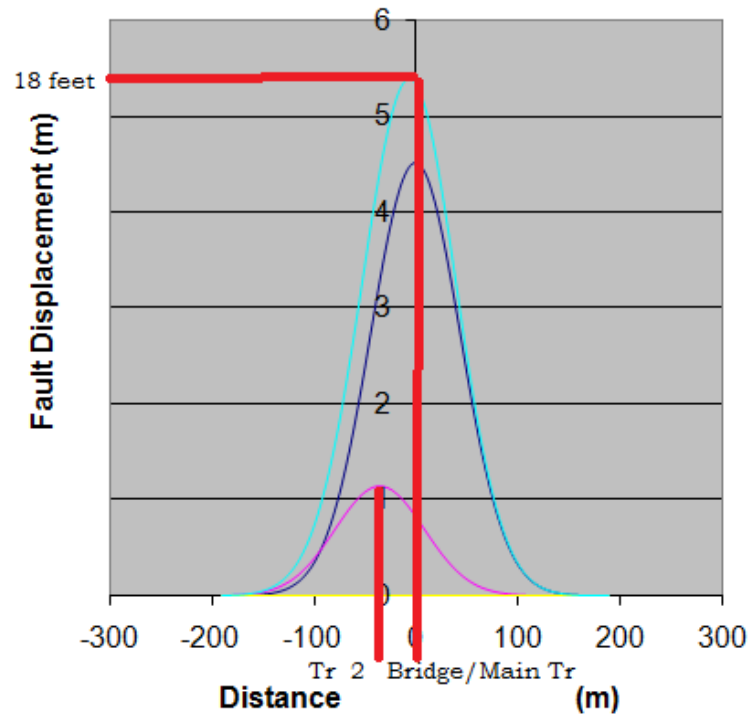
Based on these parameters and using methods described in Petersen et al (2011) and Abrahamson (2008), 18 feet of lateral offset may occur at this bridge (Figure 6) on the main fault trending NW30 to 35 degrees everywhere south of Bent 2. **Because of local variations in the ground surface, one foot of vertical displacement (either southwest or northeast side down on the vertical plane) should also be addressed**

Figure 6. Light aqua line shows probabilistic design lateral offset – 18 feet at Alder Creek bridge. Parameters used were $M_{Max} = 8$, slip rate=24 mm/yr, $asf = 0$. Main trace is weighted 80%; secondary trace is 20%; traces are approximately located. No vertical offset is expected.

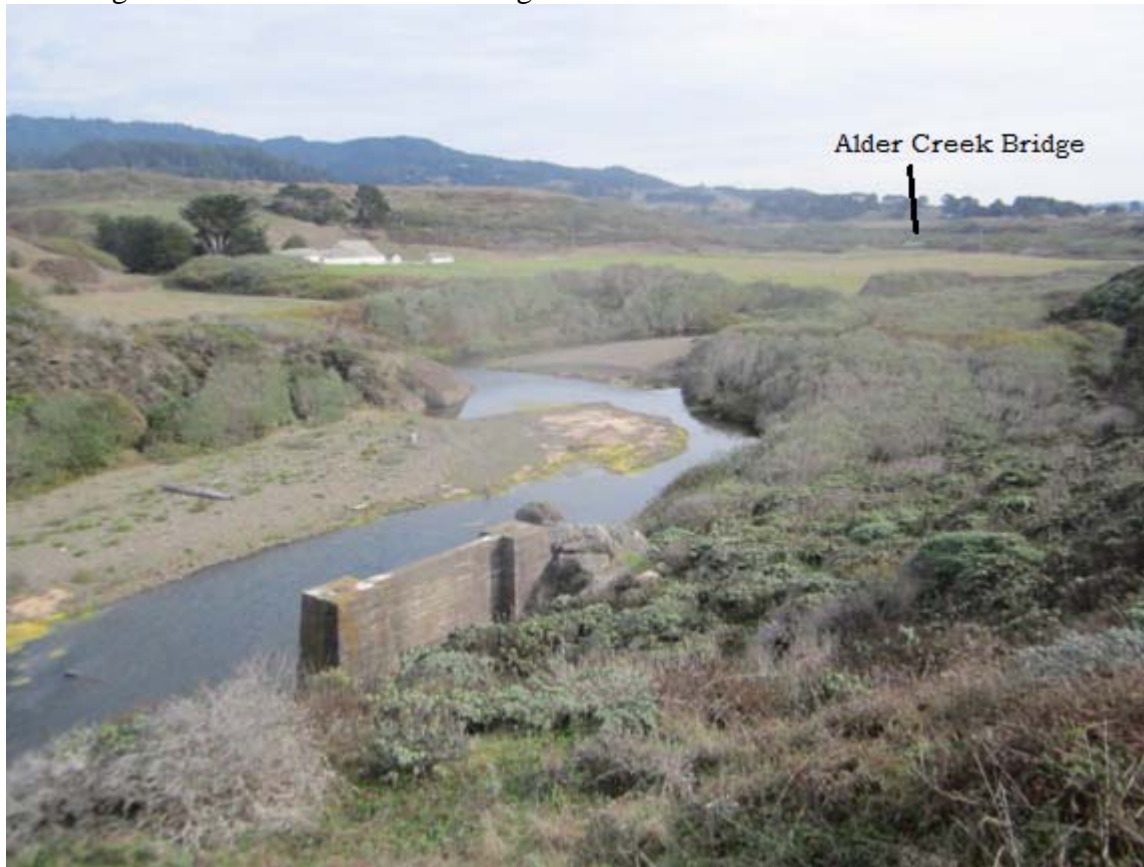
Photo 6. Same view as Photo 5 but from slightly further east; showing remains of old Alder Creek Bridge destroyed by fault rupture in 1906 earthquake.
