Memorandum

File: 04-ALA-13 PM 4.85
59-93034-N
EFIS# 0000001016-N
Leona Heights POC 33-0161

Subject: **EVALUATION OF FAULT RUPTURE POTENTIAL FOR LEONA HEIGHTS
PEDESTRIAN OVERCROSSING - BRIDGE 33-0161 ON STATE ROUTE 13, PM 4.85,
ALAMEDA COUNTY**

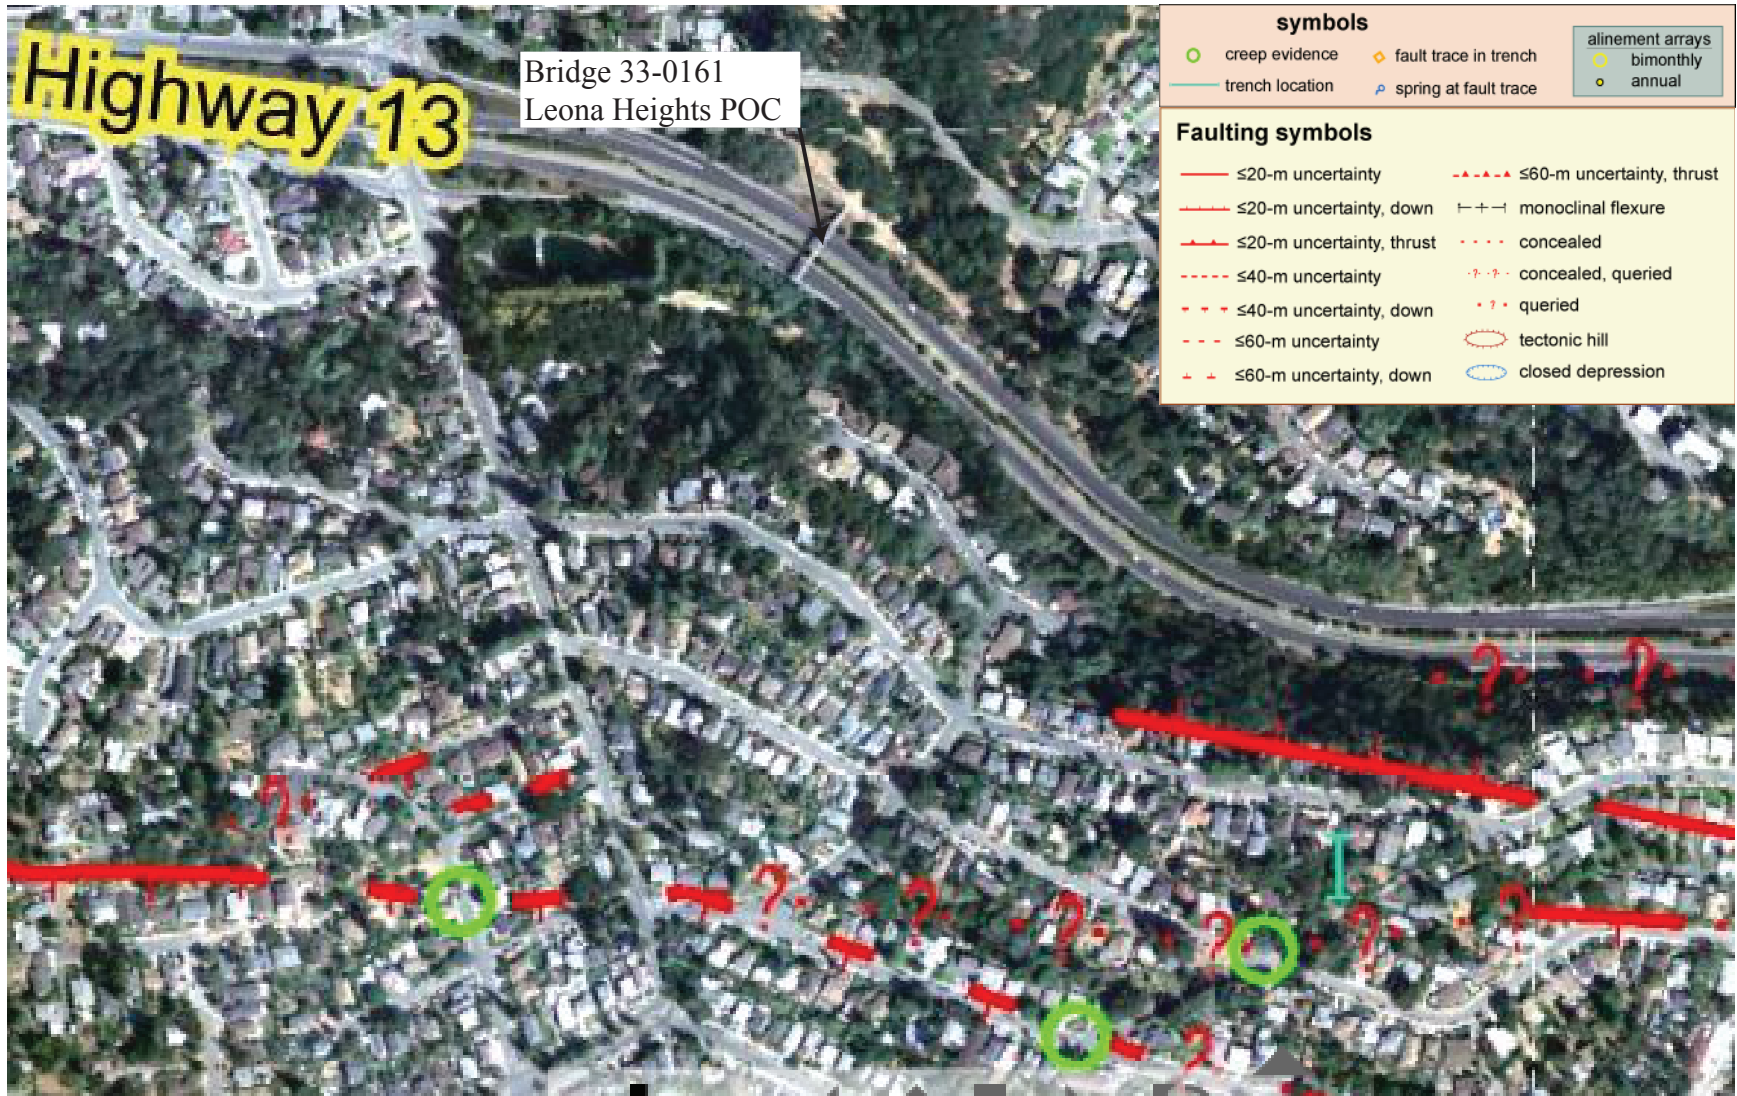
FIGURE 3

Figure 3 shows Lienkaemper's (2008) map of the Hayward fault near the Leona Heights POC. Lienkaemper's (2008) closest splay of the Hayward fault (heavy red) is approximately 330 meters (1,100 feet) west of the bridge. This map does not show every possible active fault trace, but only the most well-defined active traces (Lienkaemper, personal communication).

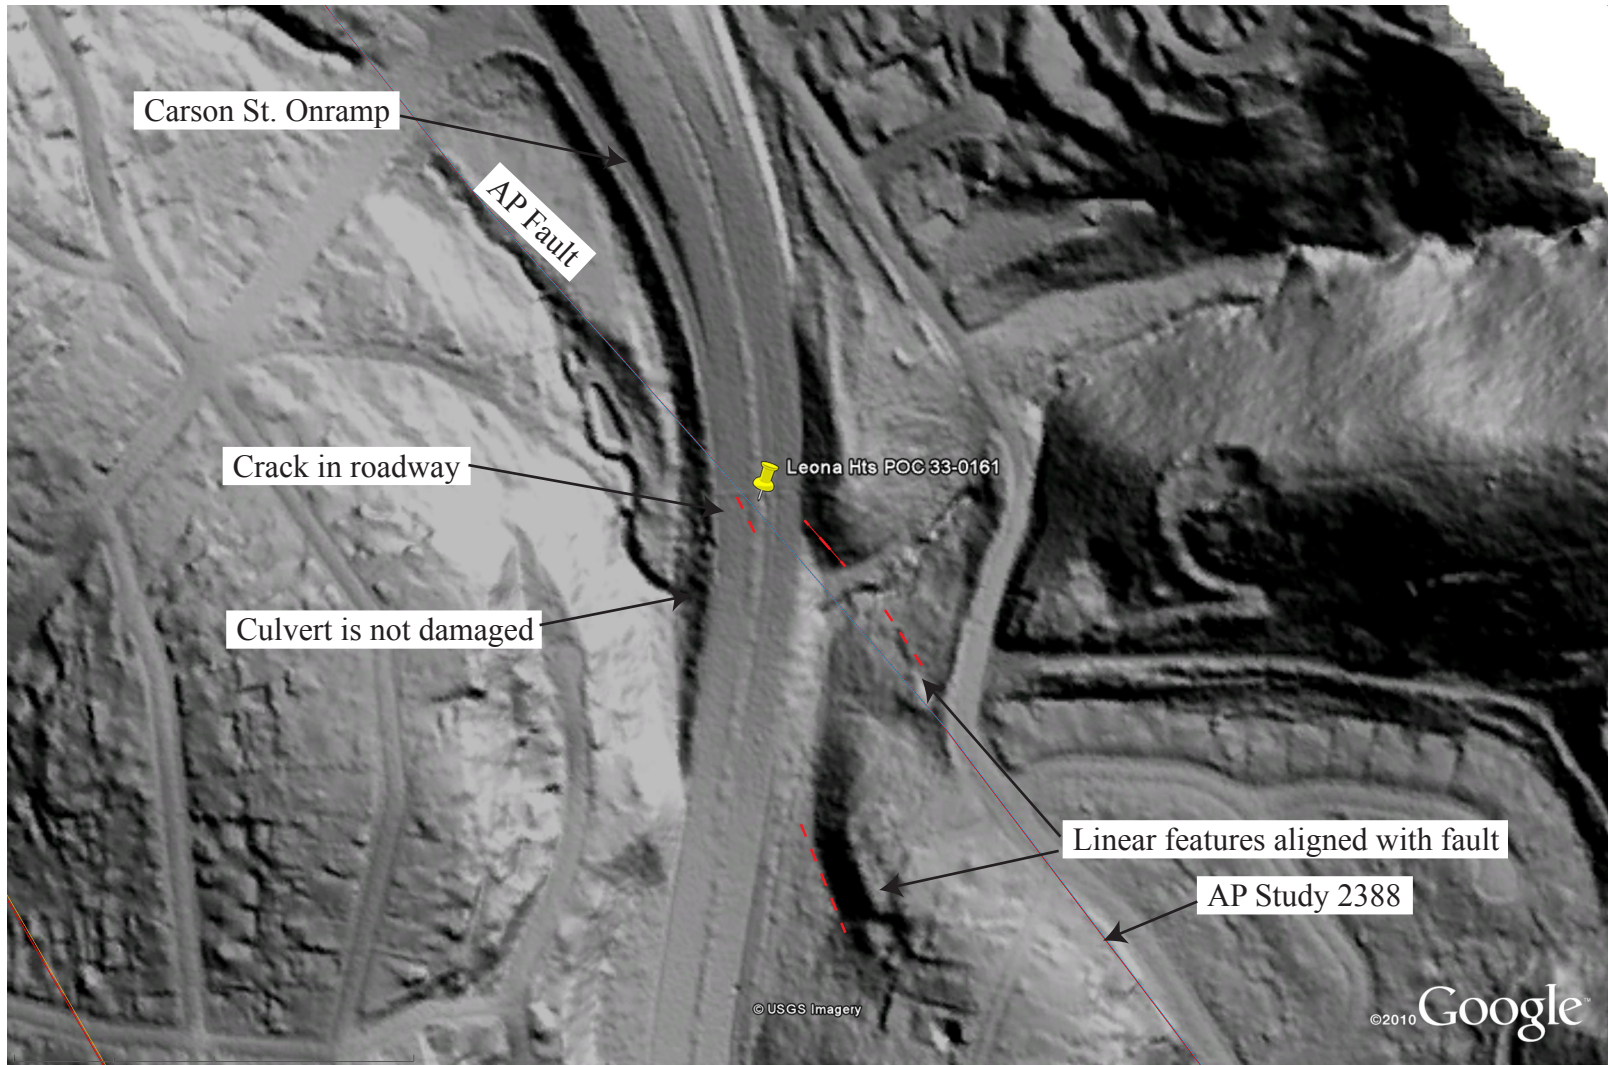
FIGURE 4

I visited the site in January 2014. In addition to the bridge and roadway damage described above, several geomorphic features that align with the regional trend of the fault were observed (Figure 4). Within Leona Heights Park a swale and two slopes next to SR 13 align with the trend of the fault. These features are consistent with active fault zone, but do not conclusively confirm Holocene activity on this mapped strand.

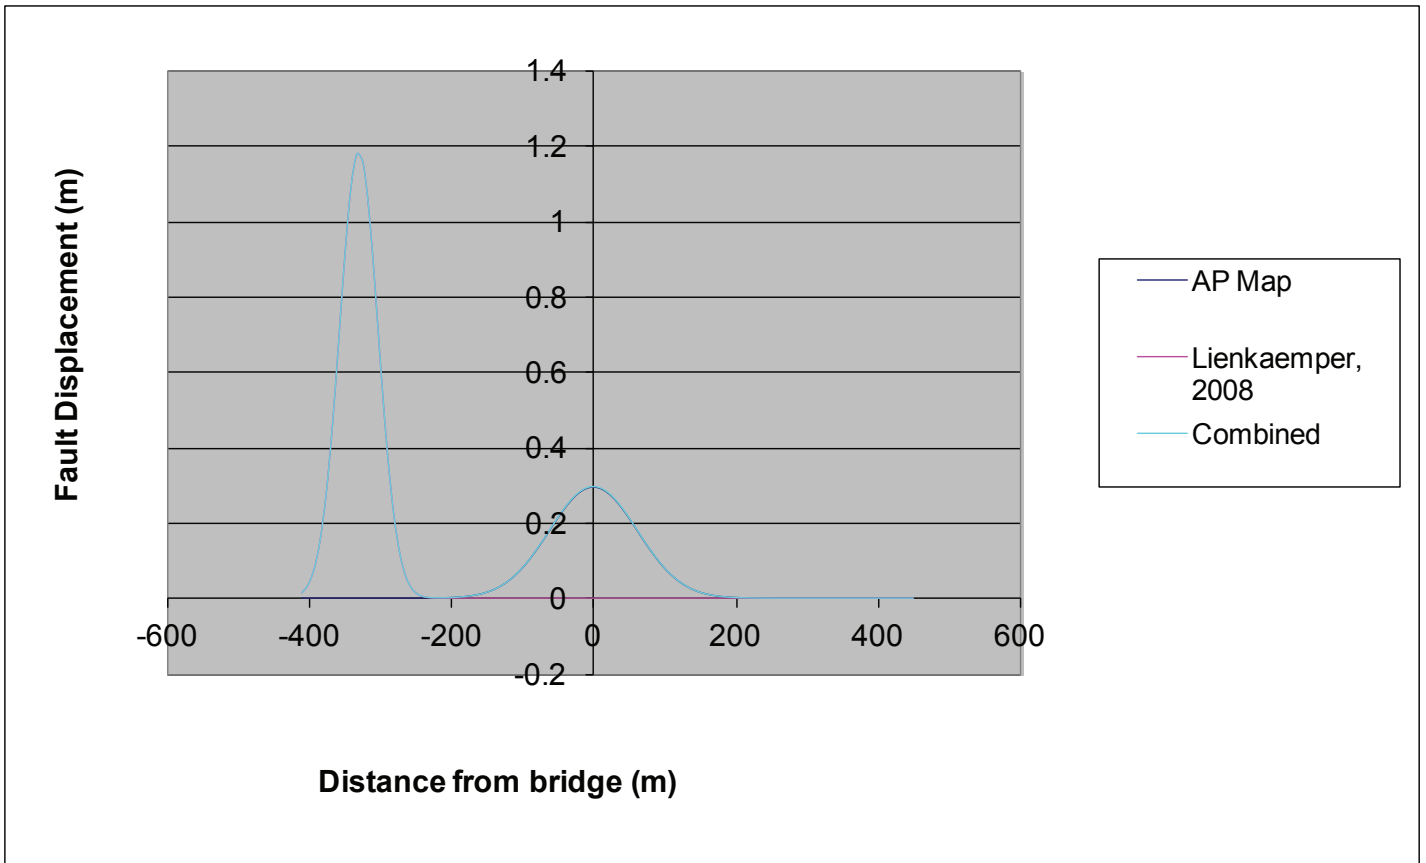
Figure 5 **Deterministic Offset 80%/20%**

The deterministic offset calculation results are shown in Figure 5. The probabilistic calculation results are shown in Figure 6. The probabilistic calculation yielded a larger offset and will be used per MTD 20-8.

Graph showing deterministic offset within the bridge footprint, with 80% of offset on Lienkaemper (2008) trace and 20% on AP Map trace. Offset at the bridge (distance = 0) could be up to 0.3 meters.

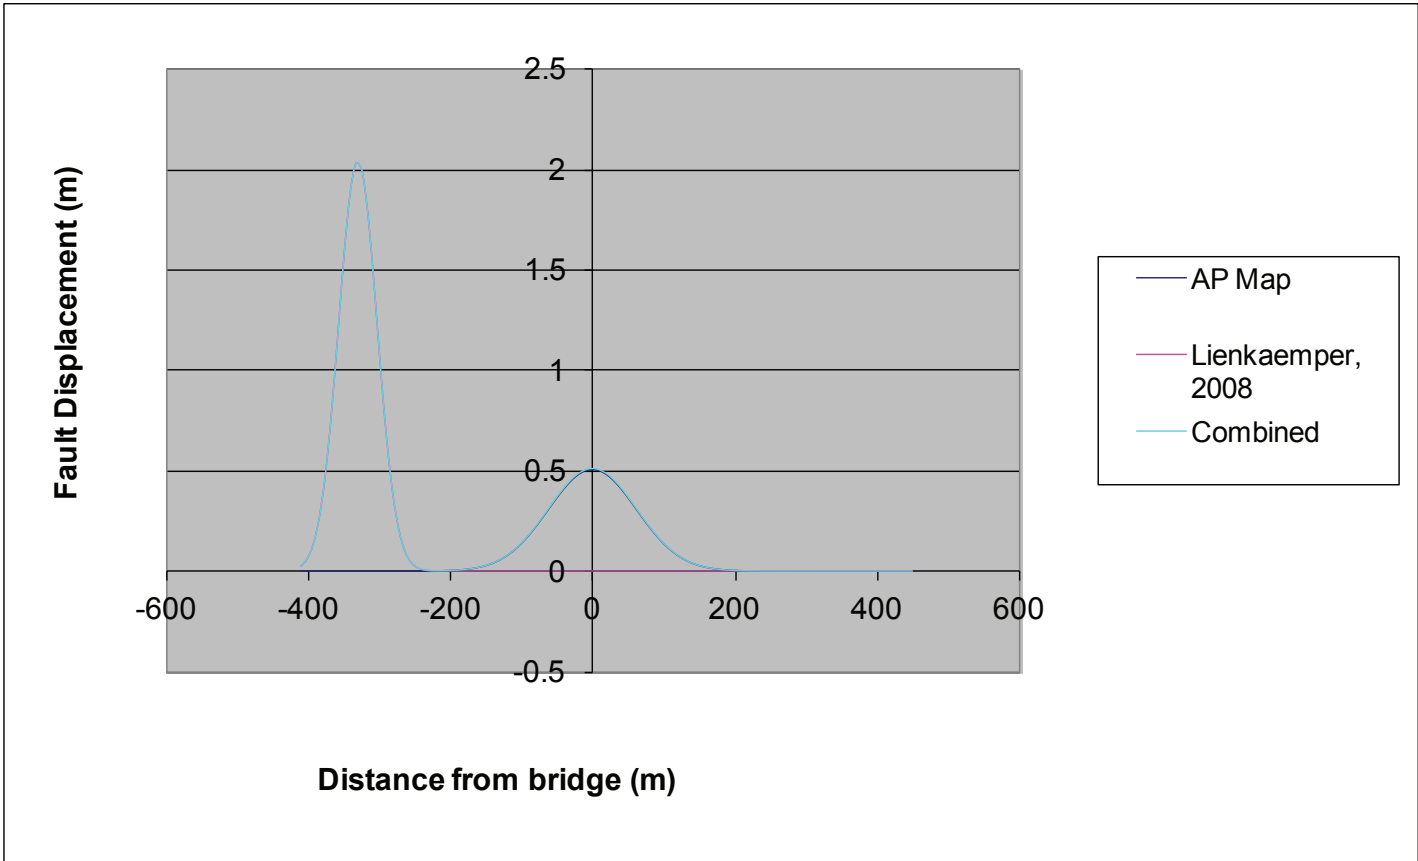
Figure 6	Probabilistic Offset 80%/20%
04-ALA-13 PM 4.85	Bridge # 33 0161
EFIS 04-0000001016-N	March 2014

Up to 0.5 meters (1.6 feet) of right-lateral offset could occur within the bridge footprint during an earthquake on the Hayward fault (Figure 6).

Graph showing probabilistic offset within the bridge footprint, with 80% of offset on Lienkaemper (2008) trace and 20% on AP Map trace. Offset at the bridge (distance = 0) could be up to 0.5 meters.

No further geologic work is recommended at this time. If the bridge is prioritized for retrofit, this study should be reexamined in case there is new work on this fault or on rupture distribution that might change the assumptions used here. If you have any questions, please contact Anna Sojourner at (510) 622-8839.
