# Memorandum

**File:** 07-LA-010-42.44  
59-93034-N  
0000001016- 6SSCN  
E10-N57 Connector  
Bridge No. 53-2004G

**Subject:** **Evaluation of Fault Rupture Potential, E10-N57 Connector, Bridge No. 53-2004G, Post Mile 42.44, Interstate 10 (San Bernardino Freeway), Los Angeles County, California**

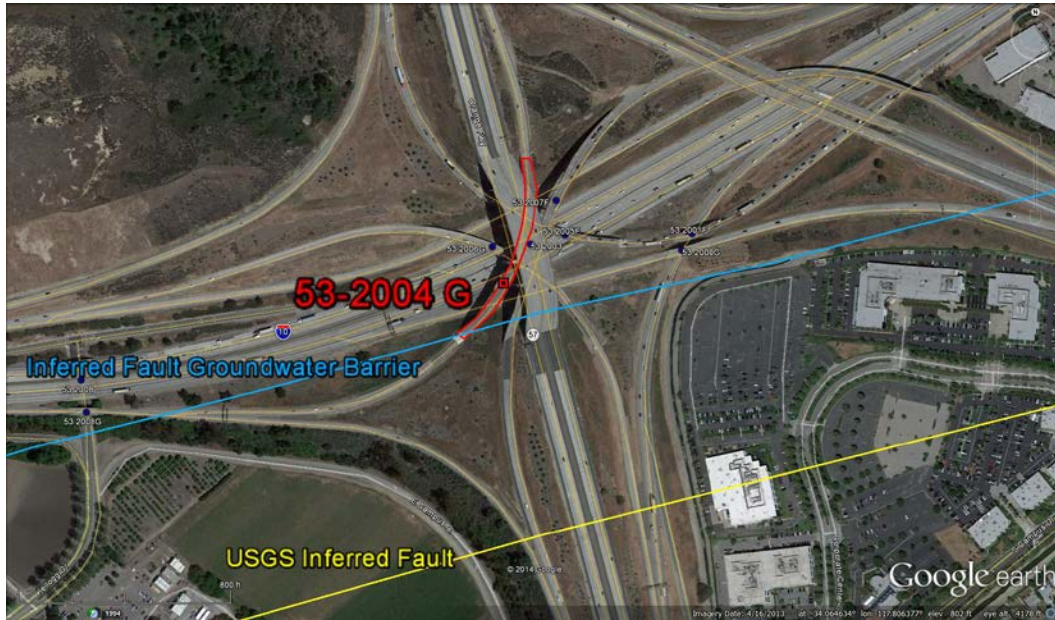
The closest inferred trace of the San Jose Fault mapped by the USGS is located about 760 feet south of the bridge abutment. This mapped fault trace is also inferred and based on groundwater data. Evidence of surface faulting was not observed at either location during a site reconnaissance conducted for this evaluation. A fault rupture analysis performed for the bridge site using Mw 6.6 and a slip rate of 0.6mm/yr, estimated 17 inches (0.42 m) deterministic and 8 inches (0.21m) probabilistic displacement. Vertical displacement may be estimated at 25% of the lateral effects due to the reverse slip component of the fault. Locally, the fault trends 075° and the local curvature of the bridge over it trends 35° over it.

Figure 1: 53-2004G E10-N57 Connector (after USGS/Google Earth Faults, 2014).

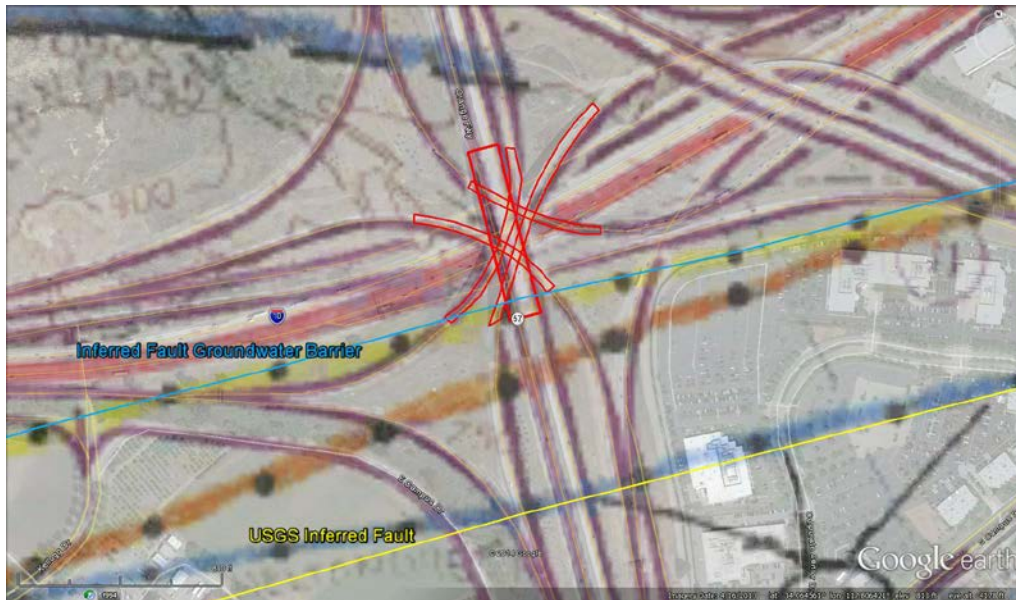
Caltrans (Merriam, 2010) reviewed the GEOCON report and concluded the reported trend of the fault and groundwater barrier may project to the east and the 57/10 Interchange (Figure 4).

A review of the Log of Test Borings for the subject bridge and 57/10 Interchange indicates the possibility of a groundwater barrier south of the San Bernardino Freeway (I-10) and under the bridge. The groundwater elevations between two sets of borings appear to be separated by up to 10 feet across a distance of less than 100 feet.

Figure 4: Image of 57/10 Interchange with USGS/Google Fault and CGS FER overlays  
Bridges shown (in red), CGS Inferred Groundwater Barriers dotted (in blue, orange  
and yellow), faults shown solid in blue and yellow). From CGS FER-68 (1977) and  
FER-68S (1978) after DWR (1970)

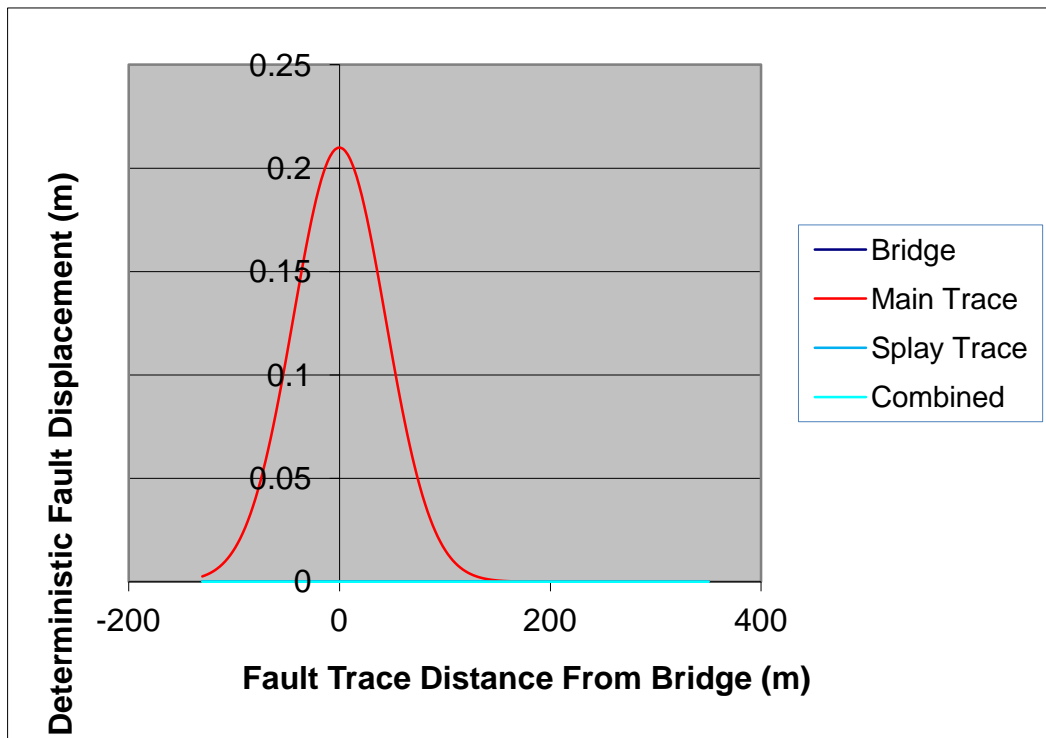
The bridge is located across a groundwater barrier inferred to be a fault, and 760 feet north of nearest identified trace of the inferred fault. Both a deterministic fault displacement analysis (DFDHA) and a probabilistic fault displacement analysis (PFDHA) of 5% in 50 years (975 year mean recurrence interval) were performed using magnitude, slip rate (for PFDHA), mapping and base map errors, and likelihood of secondary fault traces. The expected maximum magnitude earthquake for the San Jose Fault is Mw 6.6 and slip rate is 0.6 mm/yr. Accordingly the calculated fault displacement would be 17 inches (0.42m) deterministic and 8 inches (0.21m) probabilistic displacement (Figures 5 and 6).

Figure 5: About 17 inches (0.42m) of deterministic displacement at the bridge

Additional work to accurately locate the fault in the field is recommended if it is determined that the bridge structure cannot accommodate the reported amount of lateral displacement. Please contact Douglas Cook at (916) 227-4514 if you have any questions.

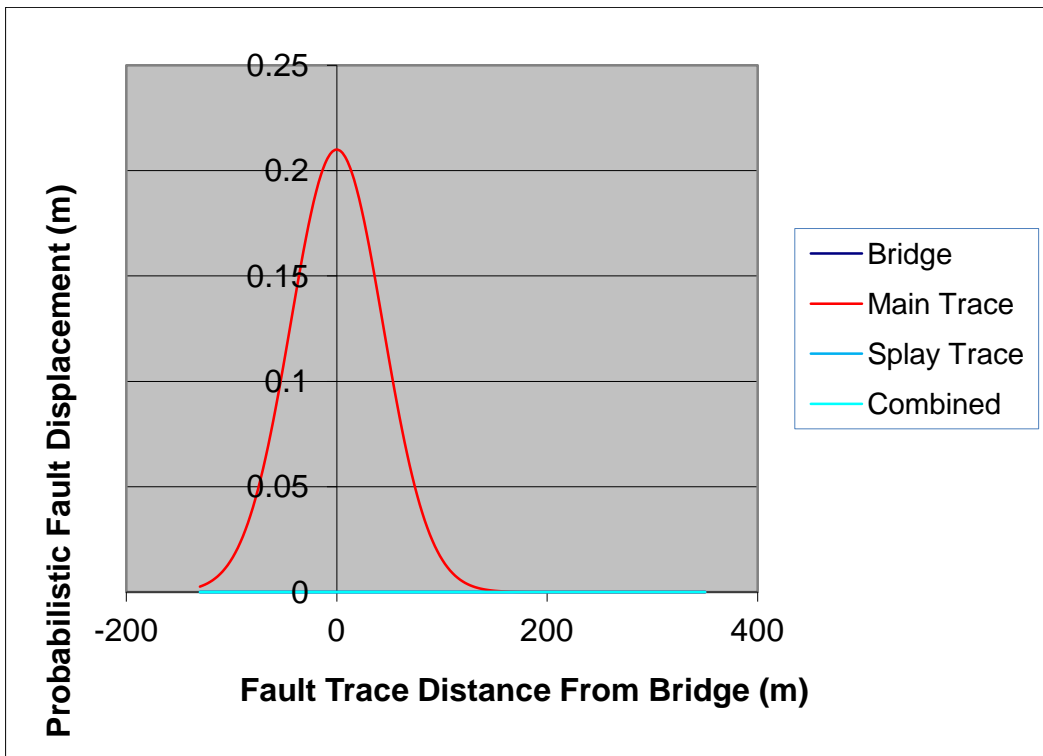
Figure 6: About 8 inches (0.21m) of probabilistic displacement at the bridge
